**Improvement Alternative Study**  
**for**  
**Town of New Scotland Highway Garage**  
Town of New Scotland  
Albany County  
State of New York

November 23, 2011

Revision A – Issued to Client

**HIGHWAY GARAGE FACILITY IMPROVEMENT STUDY  
CONCEPTUAL PHASE  
for  
TOWN OF NEW SCOTLAND, ALBANY COUNTY**

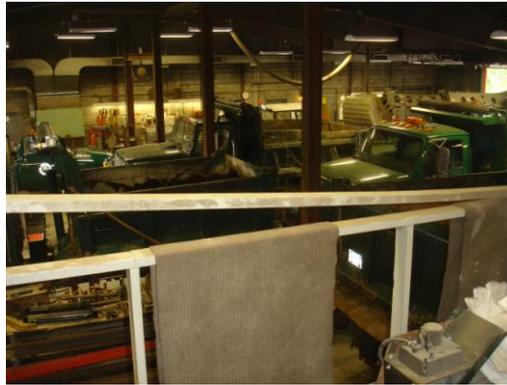
2. (-) There is inadequate space in the garage area for efficient storage, outfitting, and staging of existing trucks and equipment. During the winter season, trucks are parked bumper to bumper with dangerously inadequate access between vehicles and little to no space for truck maintenance and repair functions.

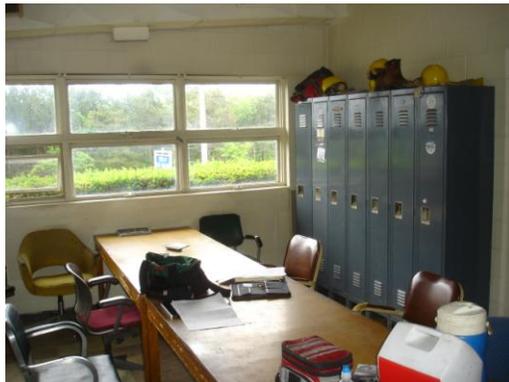
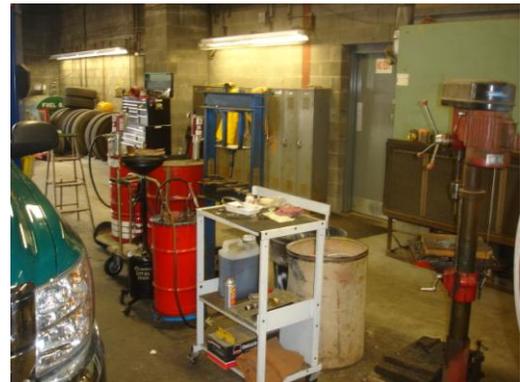
3. (-) There is no defined separation between areas for equipment repair and equipment washing and common areas of travel within the garage space. Welding operations are not easily protected and commonly occur directly adjacent to areas of common travel near administrative areas of the building.
4. (-) Facilities for field personnel are inadequate. The original employee locker room has been closed off and the area converted to parts storage for the Department of Public Works. The employee lockers are spread between a common breakroom area and the main garage space. There is little privacy for employees to change their clothes and the locker storage area environment is generally dirty and dusty. There are no shower facilities within the building for Highway Department or Public Works personnel to safely wash after returning from field operations.

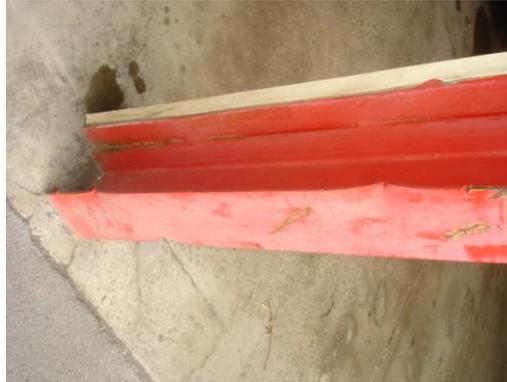
5. (-) Framing bay spacing is inadequate to safely and efficiently drive a truck with plow through overhead doorways. A number of perimeter columns have been impacted.

- a. Multiple perimeter columns in the garage space show signs of plow impacts and should be repaired and stiffened.
  - b. Concrete slab on grade has minor surface scaling, isolated minor settlement, and minor shrinkage cracking.

6. Demolition of existing administrative space and reconfiguration of overhead doors and vehicle travel within the garage area would provide adequate door widths and space between columns for safe and efficient truck travel.

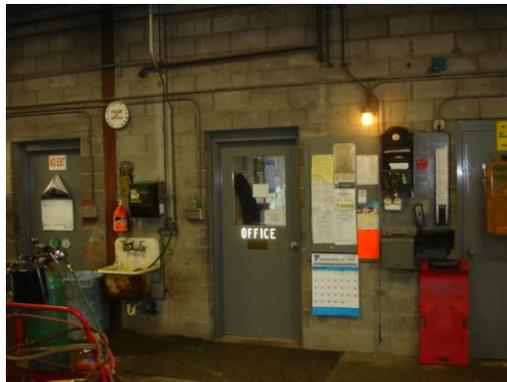
8. (-) There is inadequate fire separation between the administrative space and vehicle garage area. The wall separating these areas should have properly labeled fire doors with closers and wall fire stopping should seal all penetrations.

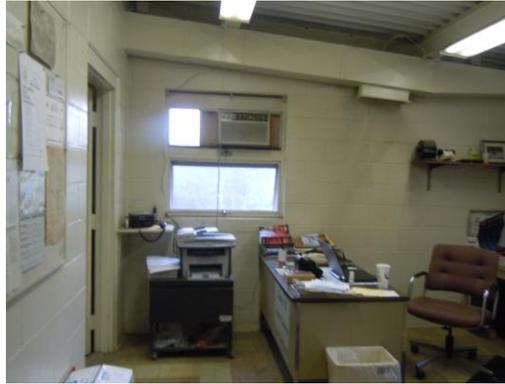
9. (-) The garage and administrative office area are typically constructed with concrete masonry block exterior walls. These walls are not insulated and window opening are of single-pane glass. In the winter season, the office and adjacent rooms are reportedly cold and heating the highway garage is building is inefficient. Proper insulation of walls and the installation of insulated glass windows would be expected to reduce energy use for the facility by 30% and increase employee working conditions.

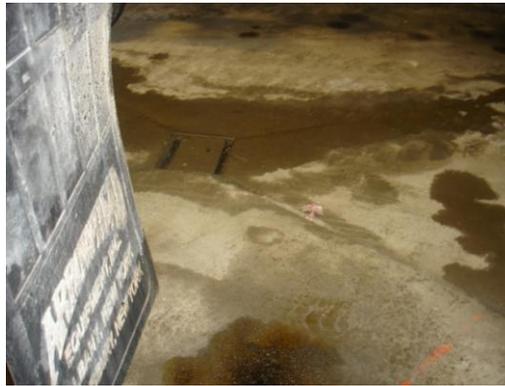
10. (-) Floor drains reportedly do not function properly and should be replaced by a new floor drainage system that can be easily cleaned and maintained.

5. There are four (4) floor drains and one (1) cleanout located in the vehicle storage area. All but one of these drains are reportedly dysfunctional. Drain lines appear to run out of the east side of the building and tie into the storm drainage system. No oil/water/sediment separator was observed.

- c. Floor drains do not appear to be functioning effectively and should be repaired or replaced.

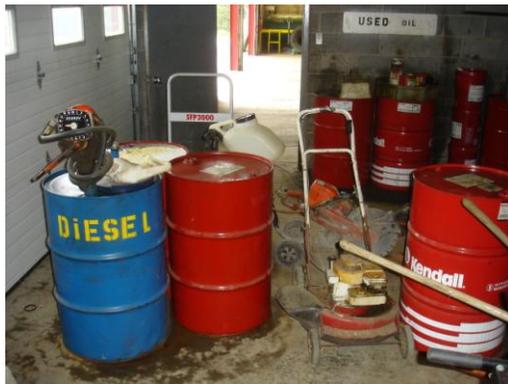
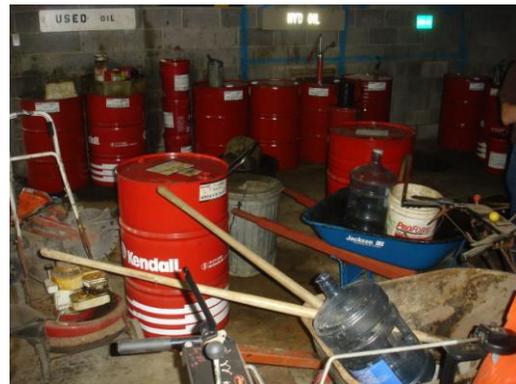
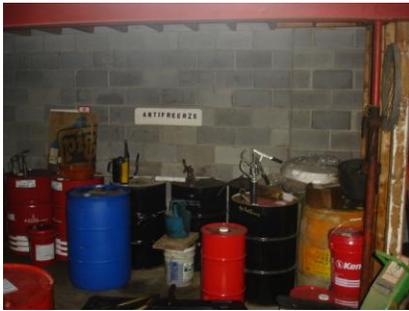
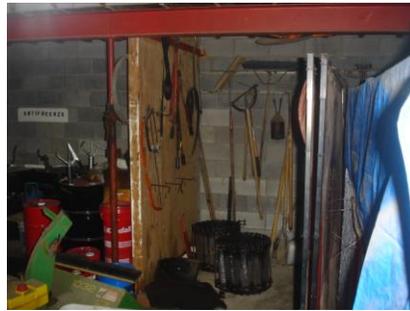
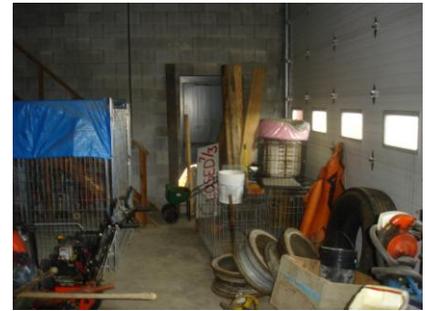
11. (-) The northwest corner of the garage is enclosed and is used for the storage of gasoline, used oil, and various solvents. The fire load in this area is high and no systems are in place for grounding or fire suppression. This area needs to be fitted with a proper fire protection system, fire rated walls and containment as per requirements of the Building Code of New York State.

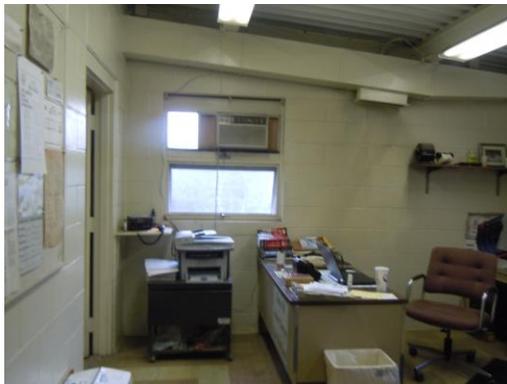
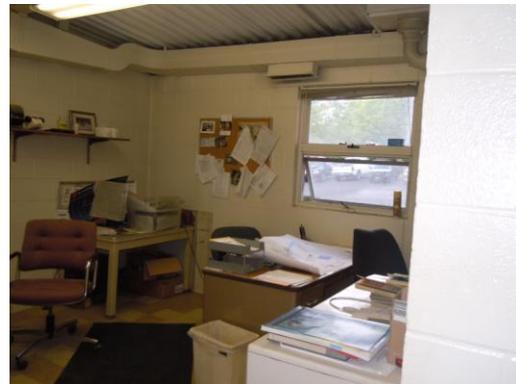
- 12. (-) The highway garage is required to have a fire alarm detection system to meet the Building Code of New York State. A properly designed system would provide safety for the building and occupants during active working hours, notify the New Salem Fire Company of an alarm and provide surveillance when the building is not occupied.
- 13. (-) Supervisory office space within the highway garage is inadequate. The Highway Superintendent, Water System Operator, Highway Foreman, and Office Clerk all share a one room office. There is limited privacy for personnel matters and limited opportunity for employees to discuss confidential issues with their supervisor.

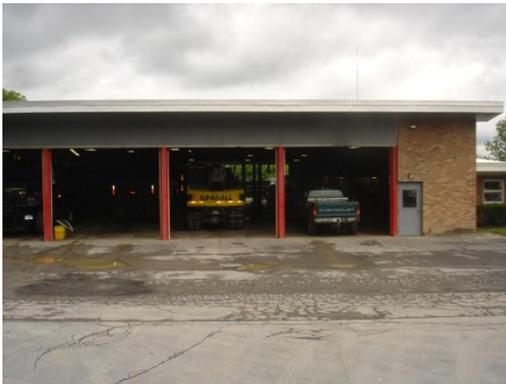
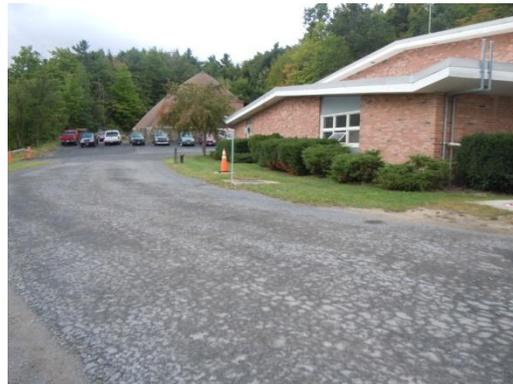
1. *Paving and Curbs*
  - a. Asphalt pavement encompasses the entire garage building while also extending to the salt storage dome. Remainder of the site consists of crushed stone gravel surface course.
  - b. General Condition: Asphalt pavement is in poor condition throughout the site. Pavement is alligator cracked and deteriorated in numerous locations. Pavement and subbase appear to be insufficiently designed for the required traffic loads.

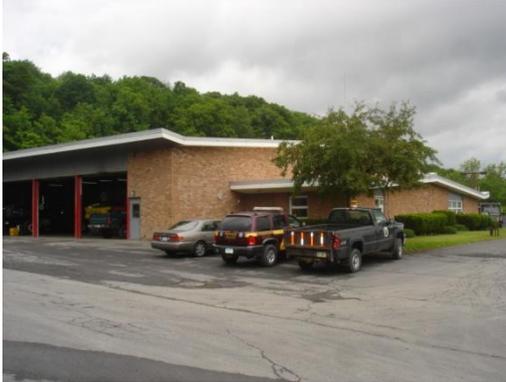
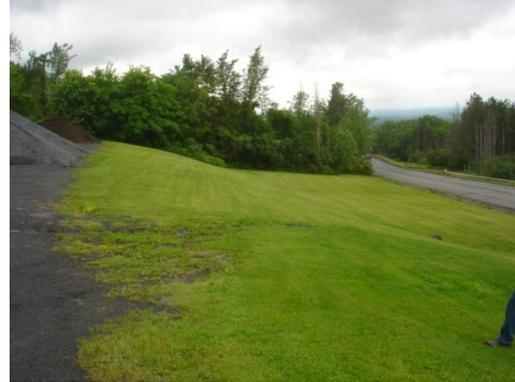
- a. A lawn area exists along the slope on the eastern portion of site, bounded by New Scotland Road. There are a row of hedges along the boundary of the garage addition as well as a small hardwood tree at the Southwest corner of the building. The remainder of the developed area is bounded by heavy vegetation and forested land.
- b. General Condition: Existing hardwood tree is in good condition. Existing hedges are in moderate condition and in need of maintenance.

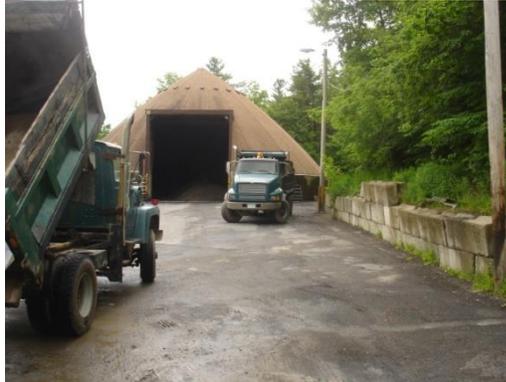
- a. An approximately 75 lf, segmental block retaining wall exists along the pavement edge spanning from the Southwest corner of the building to the salt storage dome. The wall consists of precast concrete block approximately 2' high by 2' deep by 5' long.
- b. General Condition: The retaining wall blocks are in good condition however the wall has failed and has a visible inward lean.

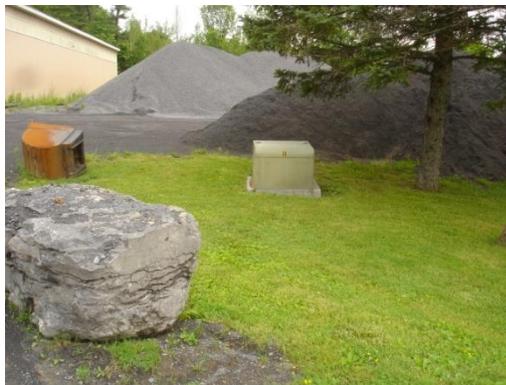
4. (-) The existing electric service is undersized for the existing facility size and type. Existing service supplied is Single Phase – 200 amps. Three Phase service is strongly recommended.

- a. Power is supplied to the site from a pole located on Thacher Park Road (NYS Route 157). The single phase service stretches west to east from Thacher Park Road to a pole located onsite, just north of the pole barn storage shed. A ground mounted transformer is located in the grass island just north of the garage building. Electrical meters are located at both the garage as well as the pole barn storage shed.
- b. General Condition: Power supply is inadequate for the facilities current and future demand.

Existing single phase service is inadequate to support the expanded facilities demand. It will be necessary to upgrade to an 800 amp, 3 phase service. Existing ground mounted transformer will be removed and upgraded to support new 3 phase service. Additional overhead service wires will need to be installed along poles between Thacher Park Road and onsite utility pole. Additional underground service wires will need to be installed between the new ground mounted transformer and the garage and pole barn storage building.
- **TELEPHONE / DATA / SCADA**

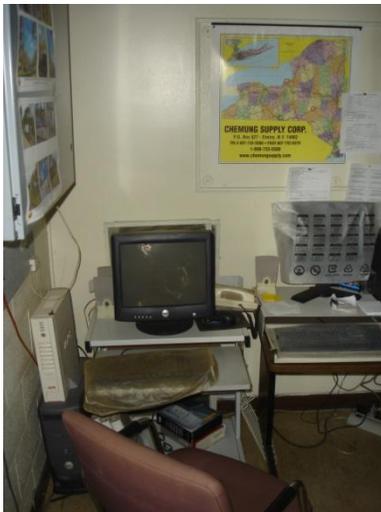
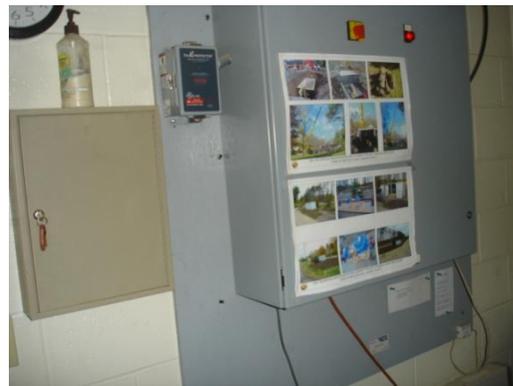
- a. The monitoring systems room contains the existing SCADA system. The SCADA system consists of a control panel that converts radio signal into useful data packets. The control panel is connected to a desktop computer and printer. The radio system includes cabling that extends to a radio antenna currently located on the roof of the building.
- b. General Condition: It is anticipated that all of the town’s SCADA system components will be upgraded and centralized at the highway garage at some point in the near future. The amount of space currently provided is likely adequate to support this upgrade and centralization. However, the existing room is subject to dust and contaminated air from the garage area which is damaging to the equipment. The air quality should be improved to prevent damage to the equipment and subsequent operational failure of the town’s infrastructure.
